# Appendix B: Site Assessment Report

ACCESSIBILITY &  
UNIVERSAL DESIGN AUDIT  
OF

# SITE ASSESSMENT ANALYSIS

PREPARED FOR:  
THE MUNICIPALITY OF THE COUNTY OF KINGS

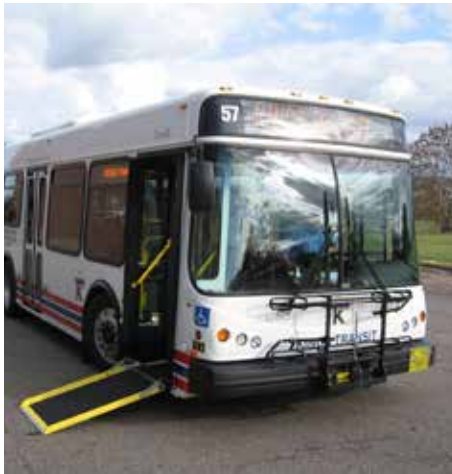
TR 4 | Low floor buses  
Source: Kings Transit Authority, 2020

Transit in Kings County is accessible as all buses are fully accessible. Low floor buses are now the standard for transit and provide great accessibility. As seen in image TR4, the buses have ramps and a wide entrance to accommodate wheeled mobility devices. Inside the bus, space is provided for users to tie down wheelchairs. We heard from some users of the bus system that the tie-downs were sometimes difficult to use.

Although there are accessible buses with low floors, kneeling capabilities and ramps - they are sometimes difficult to maneuver when exterior conditions worsen. Ensure floor and ramp surfaces are kept dry, free of ice and slip-resistant.

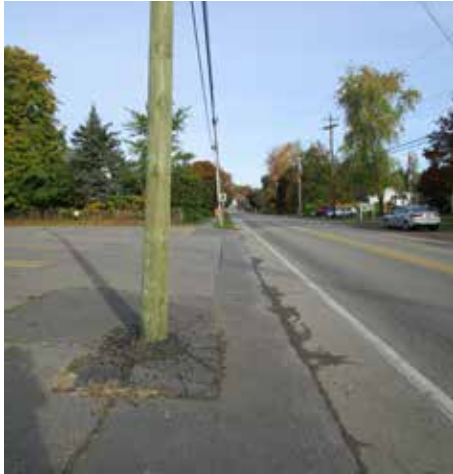
**PS 1 |** Uneven sidewalks in front of Port Williams Library

The pathway outside of the library is in need of an accessibility upgrade. This narrow path can only accommodate single pedestrian traffic. Those using wheeled mobility devices would be unable to pass next to each other and one user would be required to leave the pathway. The pavement is uneven and has no tactile indication warning pedestrians they are leaving a sidewalk and entering a parking lot.

Pathway surfaces should be firm, level and slip-resistant. Worn pavement presents tripping hazards for some users. Pathways should be regularly maintained and kept clear of snow and ice.

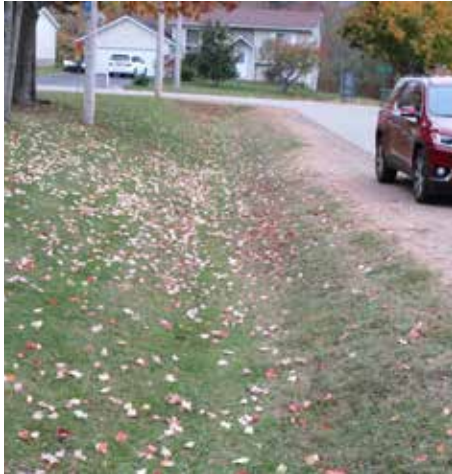
**PS 3 |** Lack of sidewalks forces users to walk along an active roadway

The lack of sidewalks in residential areas forces users to walk along the road or ditch. It was observed that when parked on the side of the road pedestrians would have to choose between walking in the ditch or on the active road.

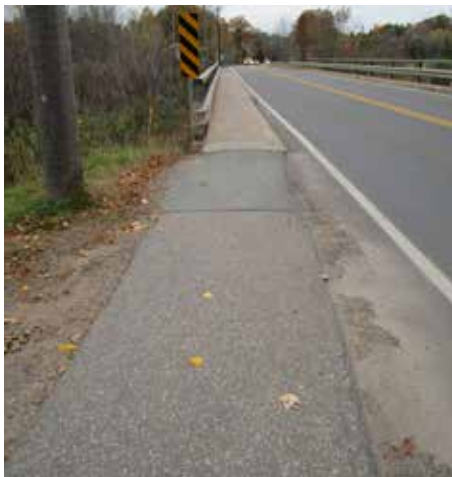
**PS 4 |** Single pathway with ramp crossing Kingston bridge

The Village should advocate to have the Province upgrade bridge crossings as part of the mandated Accessibility Plan. Kingston bridge is in need of an accessibility and pedestrian retrofit. The sidewalk is on an elevated platform and only accessible from steep ramps. No colour contrasting strip is found on the curb edge where it drops to roadway. If two users in wheeled mobility devices would enter the pathway from opposite end one would have to back up to let the other through.

Bridge crossings are currently inaccessible. Paved pathways end prior to bridge crossings and people are forced to traverse the roadway and gravel to get to the bridge sidewalk. The bridge sidewalks are too narrow for even a single wheelchair to use and a steep, asphalt ramp is provided to access them. The Port Williams bridge was covered in road gravel at the time of our visit, making it very slippery. LPF recommends widening the sidewalk and providing a color contrasted warning strip along the curb edge to warn of a drop into the roadway. A guardrail on the road side of the sidewalk can be used in future construction to increase safety.

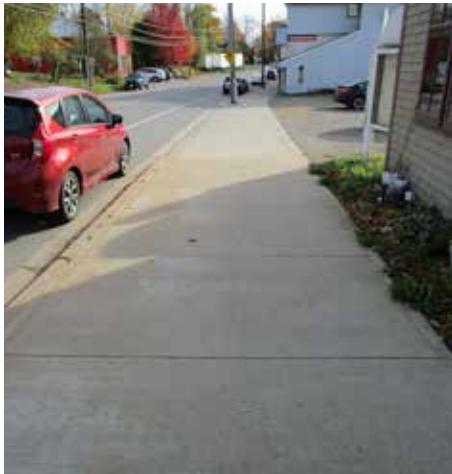
**PS 5 |** Canning sidewalk that is wide enough for two wheeled mobility devices

The sidewalk seen in image PS5 is a good example of how a sidewalk should look. The sidewalk is wide enough to accommodate passing and any obstructions in the path do not reduce the width down to an inaccessible width.

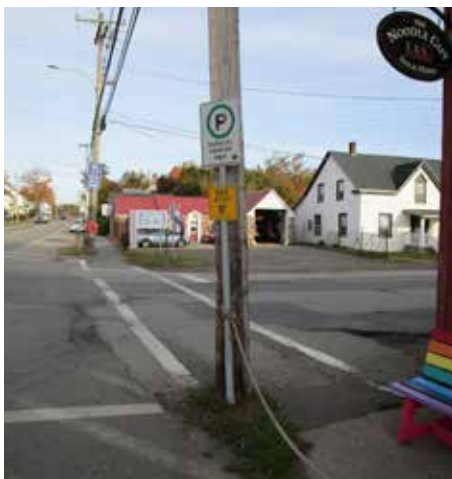
**PS 6 |** Sidewalk in Port Williams is restricted by obstacles along the sidewalk

This crosswalk represents the current state of accessibility in Kings County with obstructions hindering access to the crosswalk. The crosswalk path is not a single surface and does not have any tactile warnings before to indicate entrance into a roadway. There are no signals to notify vehicle traffic or pedestrians respectively. Finally, vertical signage is not present to indicate a road crossing.

A colour-contrasted, textured strip at least 50mm in width should be placed at locations where grade changes occur in the pathway. Curb cuts with tactile walking surface indicators should be provided at all cross walks. Visual and audible signals should be provided at crossings to help direct both pedestrians and vehicles of the crosswalk. Many of the crossings we visited also had painted pavement and vertical signage for the crossing and it is recommended that the same is done for more of the intersections.

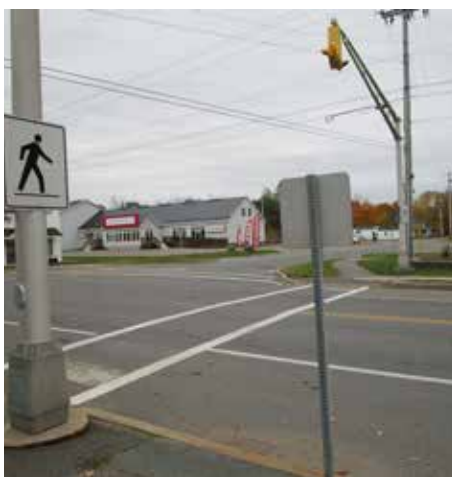
**PS 7 |** Updated crosswalk in Kingston

The crosswalk in image PS7 demonstrates an improvement to the pedestrian experience. With flashing lights and signage, oncoming vehicles are warned of pedestrians crossing. The crosswalk could further be improved with tactile warnings to indicate a entrance into an active roadway.

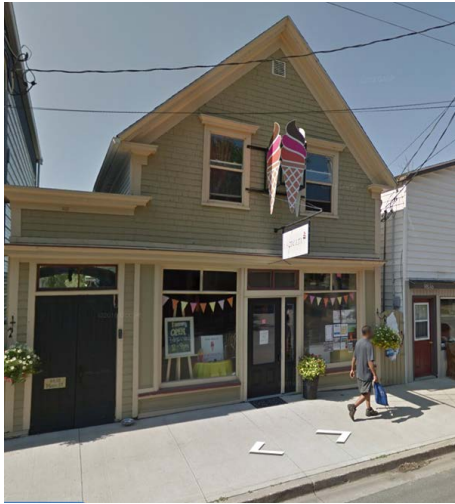
**KA 1 |** Front entrance to a building along main street in the Village of Canning

Incorporating accessibility into entryways of existing businesses shall be a future consideration of all sidewalk construction.

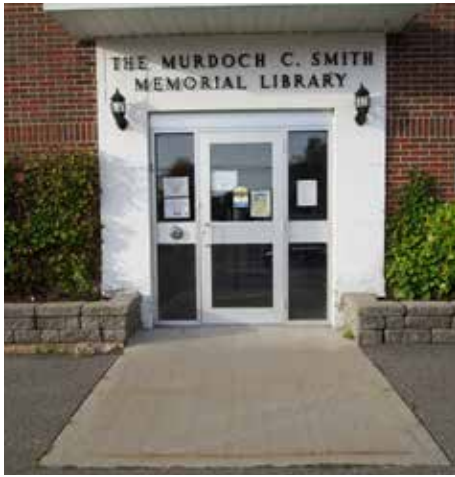
**KA 2 |** Accessible front entrance at the Memorial Library in Port Williams

This site has good access with a level platform at the entrance. The door is accessible and has a automatic opening button on the side wall. The button location could be improved, as it is within the swing of the door and users would likely get hit by the door once pressed. Lighting is good and the entrance provides shelter from inclement weather conditions.

All public building entrances should have a level landing at the door that can accommodate the turning radius of a wheelchair. Automatic door operators should be placed out of, but adjacent to, the door swing and no more than 1500mm from it. Where there are two doors, such as in a vestibule, ensure both open in unison once the automatic door control is activated. It is recommended that all accessible entrance doors, as well as accessible washroom doors, are equipped with automatic openers.

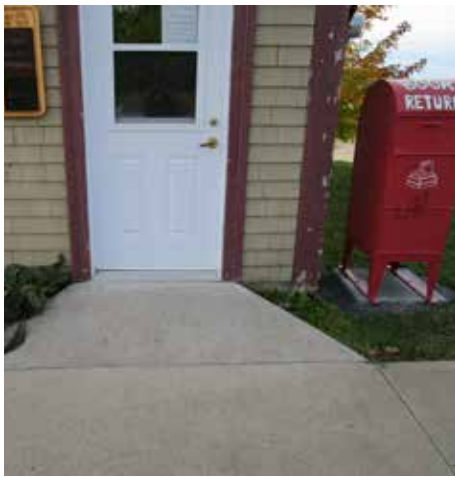
**KA 3 |** Canning Library with sloped access and unaccessible book return

This site has tried to increase accessibility of the entrance by adding a ramp to the door. The ramp is steep and does not provide a level landing at the top so that a user can maneuver the door. The door is also not equipped with an automatic opener. The after-hours book return is located off the level pathway and is over accessible height. The signage on the building is not colour contrasted and does not have any tactile characters on it. In addition the signage material creates glare making it hard to read from a distance.

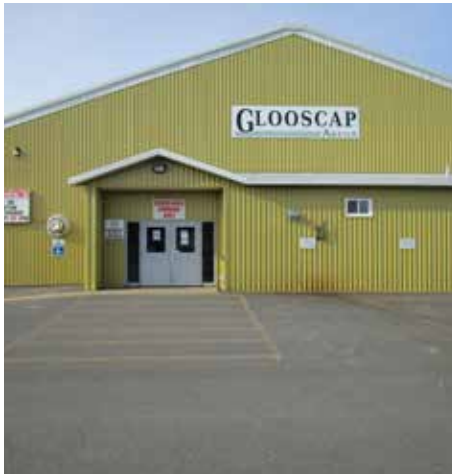
KA 4 | Front entrance to arena

This building has some good accessibility features. The front entrance is level and wheelchair accessible.

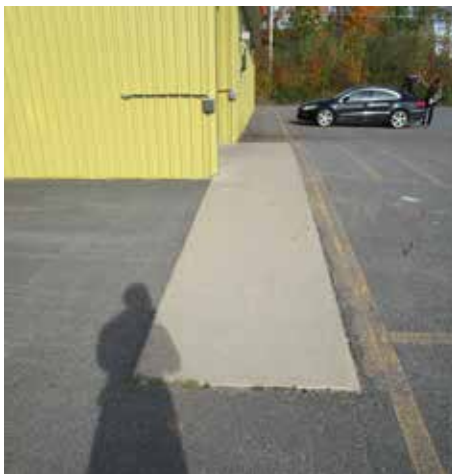
KA 5 | Accessible ramp to the south of the front entrance

The ramp on the south side of the entrance is provided for accessible access to parking stalls. The current ramp can present a tripping hazard for some users due to its lack of colour contrast. The lack of railing reduces way finding for those with reduction in visibility. In addition a railing would ensure that no vehicle could encroach on the accessible pathway when parking in the adjacent stall.

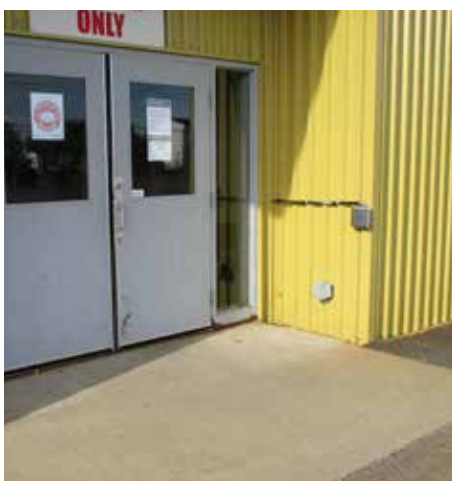
KA 6 | Power Door Control at Entrance

Automatic door openers are provided and are located out of the swing of the doors.

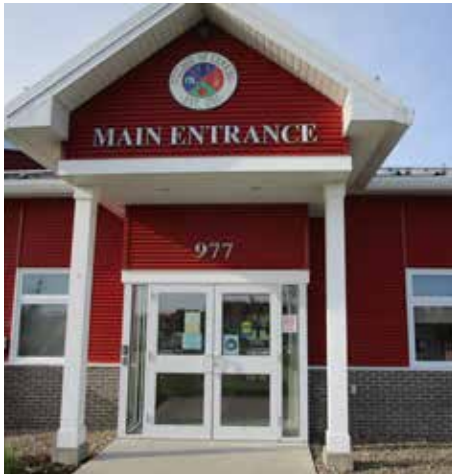
**KA 7 |** Front entrance to the Canning Fire Hall

The newly constructed fire hall in Canning has a firm, level pathway leading up to the front entrance. The entrance has push button access located at the face of the doorway. Using the button would require the user to be within the door swing. Some other accessible features of the entrance include the vertical signage, the shelter from elements, and the outdoor lighting.

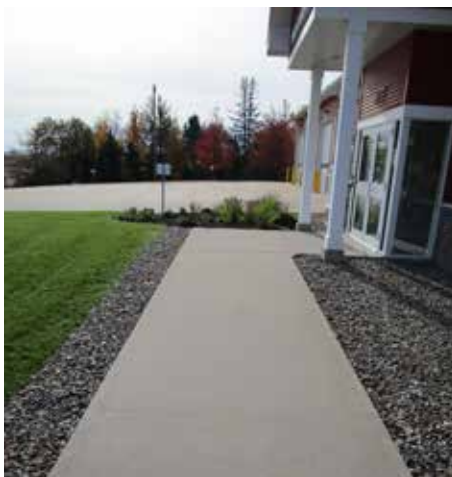
**KA 8 |** Pathway leading to the Canning Fire Hall

A wide pathway leads to the front entrance of the fire hall. The sidewalk is wide enough to permit passing of two wheeled mobility devices. This front pathway is a good example of what the County of Kings should strive for to achieve universal design.

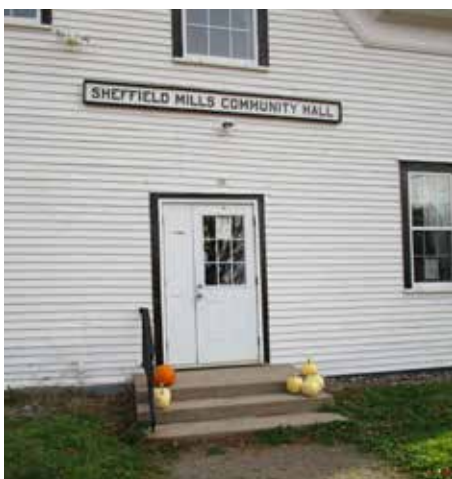
**KA 9 |** Stairs leading into the front entrance of the Sheffield Mills Community Hall

Community halls often have accessibility limitations both physically and visually, mainly due to their age. The front entrance to the building often requires a user to climb steps. Halls that do not have a main accessible entrance may be forced to locate one at the less desirable side of the building. Doors with a lever style knob are more accessible than a door knob handle which requires full dexterity.

The Municipality can further encourage these public building upgrades within grant applications.

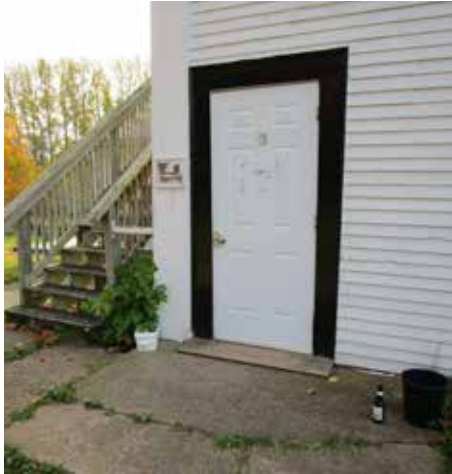
KA 10 | Accessible entrance to Sheffield Mills Community Hall

Community Halls often have a side entrance that doubles as the accessible entrance. The visual appearance of the side door is often less welcoming than the front. The landing before the door is not a solid, level surface and the door has a knob on it. These entrances often do not contain signage promoting the use of the door as an accessible access point and there is often no accessible path leading to the doorway.

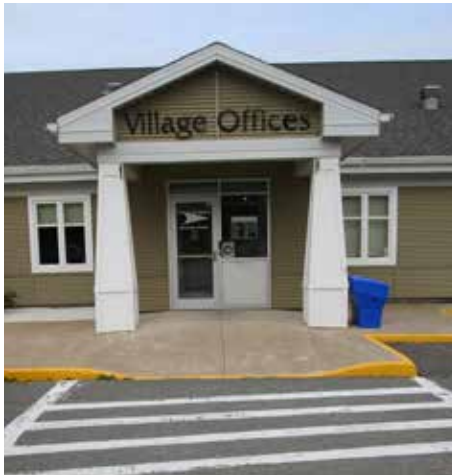
KA 11 | Front entrance to the New Minas Village Office

The village office in New Minas was another good example of public buildings with good access. The level entrance was one solid surface with enough space to maneuver to use the door. The push access was located on the front wall which might put the user in the way of the door swing. The entrance was covered and had good lighting and signage.

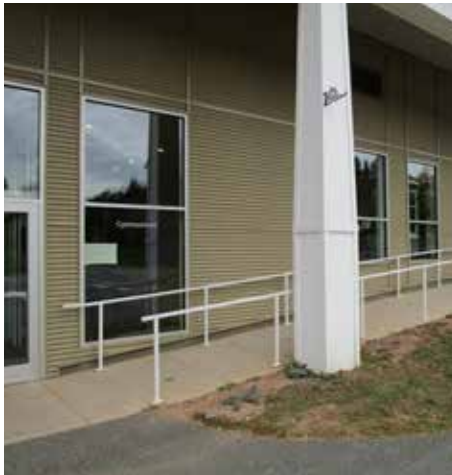
KA 12 | Exterior ramp to access interior rooms within the village office

Louis Millett Community Complex (New Minas) The community complex is two levels and does not have an interior elevator. An exterior ramp is provided but is not inclusive . The provided railing does not contain a lower rail which could cause harm to those in a wheelchair.

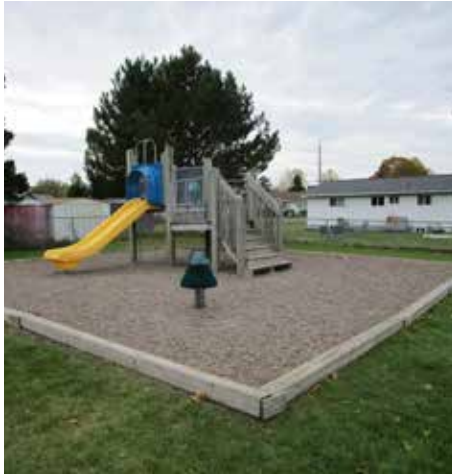
**KA 13 |** Typical unaccessible playground found throughout county

This playground shows the current state of many of the playgrounds in Kings County. With a wooden curb and pea gravel, the playground is not accessible. There is also no accessible playground equipment.

Playgrounds should have a level entrance and be free of curbs that limit access. The ground surface of playgrounds should be level and firm to promote interactive play between children of all abilities. Accessible equipment should also be provided at locations throughout the park (not only in one location). LPF recommends that the Municipality and Village websites highlight which playgrounds are currently accessible until upgrades can be done to the remaining sites.

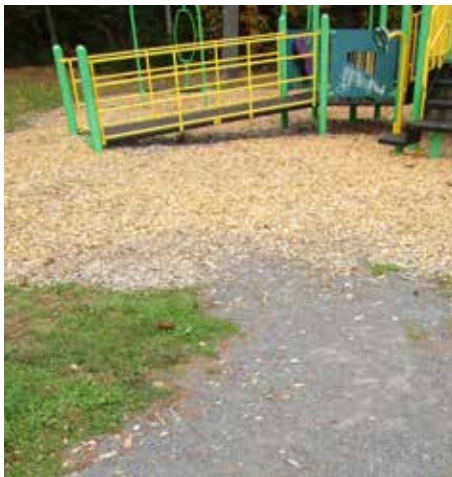
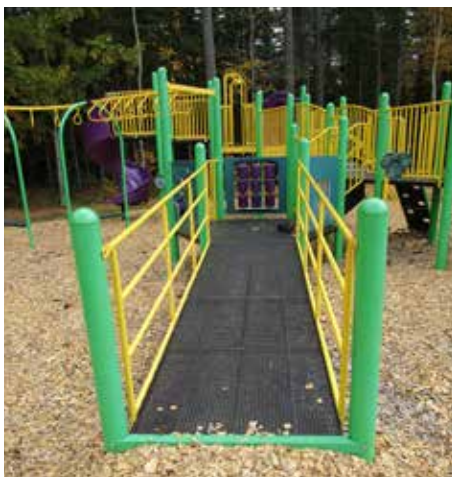
**KA 14 |** Entrance path to accessible playground in Centreville

**KA 15 |** Ramp leading onto an accessible playground structure

One of the County of Kings Accessible playgrounds is located in Centreville. This example of universal design is a good step forward toward a more inclusive playground. The pathway to the playground is level and offers a route for anyone using a wheeled mobility device. In addition, access to the play structure is also inclusive. A ramp is provided for anyone who wishes to go up onto the structure. The ramp offers an upper and lower railing and is colour contrasting for those with limited vision.

The accessible playground is a great addition to the county, but could still be improved. The wood chips that line the ground can get caught in wheelchair spokes. With heavy rain or snow, pooling might occur if a hole was dug by a child in the wood chips.

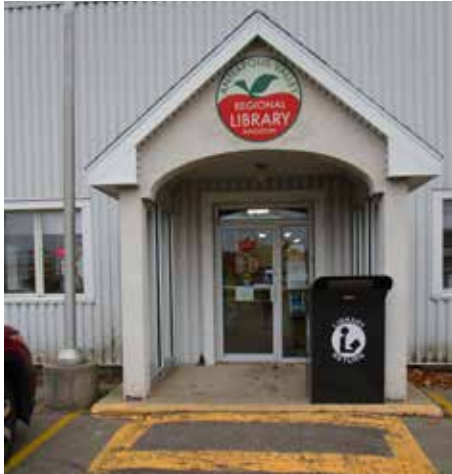
KA 16 | Kingston Regional Library

The library in Kingston has a firm and level entrance landing. The entrance is covered, has signage, and there is outdoor lighting. The book return is placed so that it blocks manoeuvring space at the door and provides a reduction in entrance visibility. The entrance is also on a podium raised above the parking lot. The change in grade at the sides should be highlighted with colour contrasting stripping to warn users of a drop.

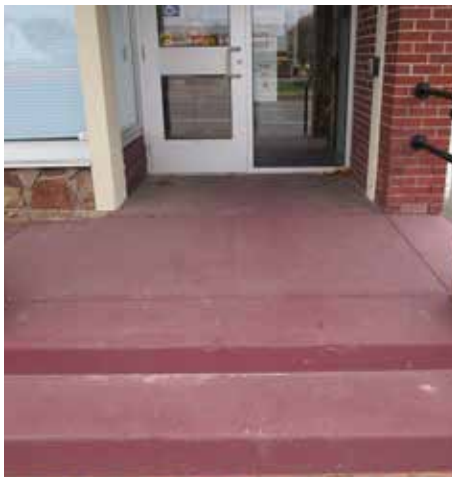
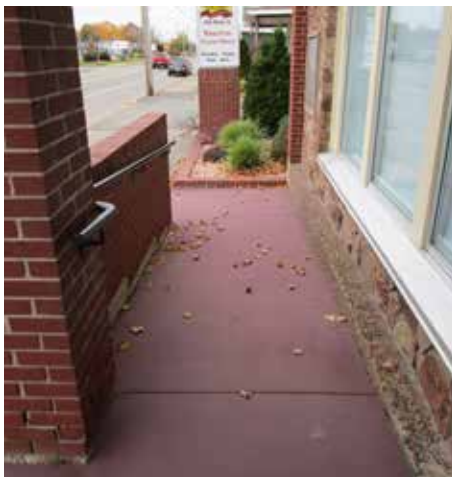
KA 18 | Front door to the Kingston Village Office

The village office in Kingston has accessible access. The entrance is covered, has good vertical signage and has a narrow ramp to the doorway. The automatic door button is located in a spot on the wall that is within the door swing. In addition the ramp leading to the entrance follows a unusual path where a 90 degree turn is located with a slope change. Current ramp designs have a level platform for users to change direction. With a slope and pathway change users might lose control.

KA 19 | Ramp leading away from entrance

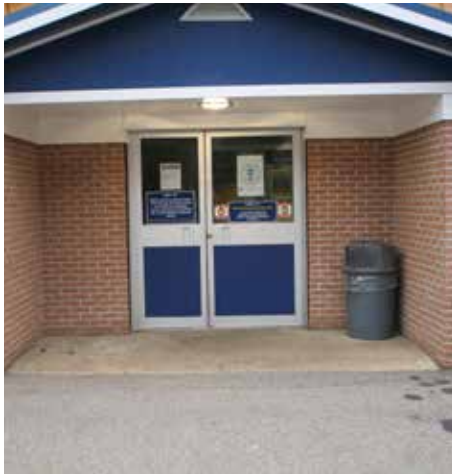
KA 20 | Credit Union Centre in Kingston

The recreation centre entrance in the Village of Kingston is in need of an accessibility upgrade. The existing door handles on the front entrance are not access friendly as they require full dexterity to pull. The entrance also does not have push access. The entrance is also on a slightly sloped podium that could cause unknowing users to stumble. Some elements are good on the entrance such as the outdoor lighting and the protection from elements.

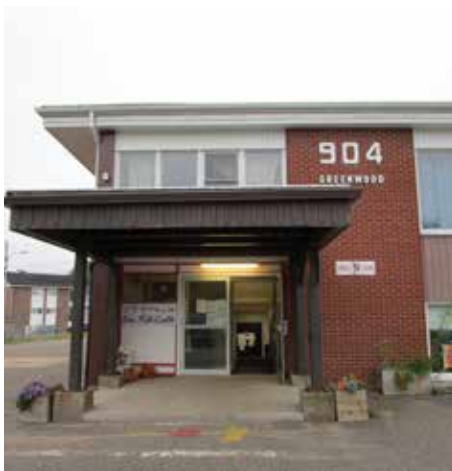
KA 21 | Front door to the Village of Greenwood Office

The Wee Folk Centre located in the Village office building does not have an accessible front door. The main entrance is located on a platform with a single step up. This step up has no visual indication and could pose a tripping hazard to those with reduced visual ability.

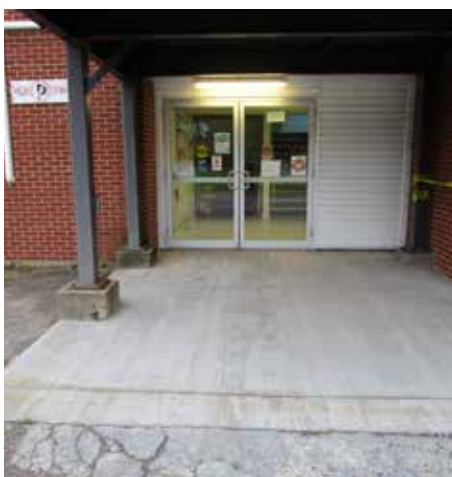
KA 22 | Accessible entrance at the Wee Folk Centre in Greenwood

There is a secondary entrance on the building that is accessible. The accessible entrance has a push button that is located outside of the door swing.

In addition, a low slope brings users to the door.

Attention could be given to the ramp as the surface is beginning to show signs of disrepair.

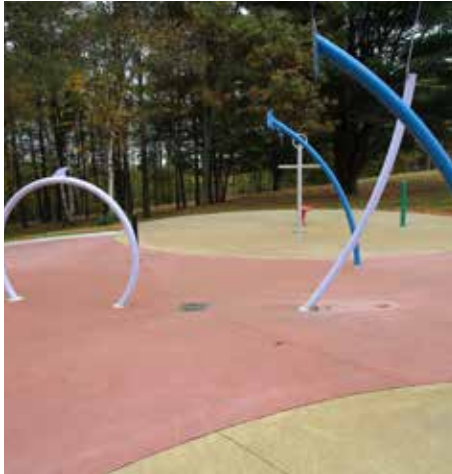
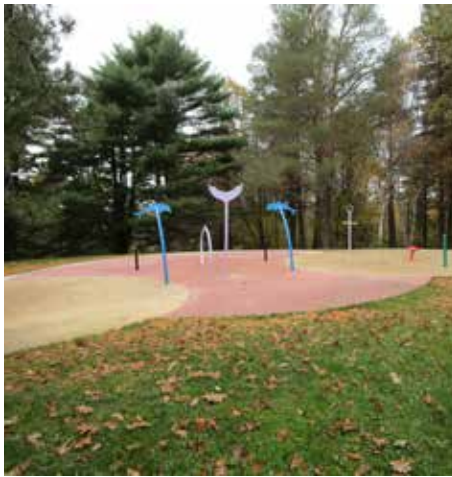
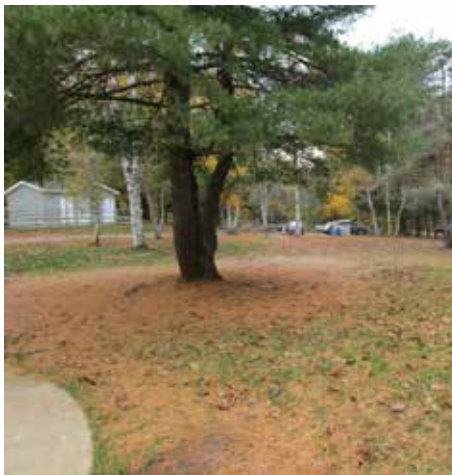
KA 23 | Lockhart Ryan Memorial Park Spray Park

KA 24 | Access to the Lockhart Ryan Memorial Park Spray Park

KA 25 | Pathways from Parking to the Main Park Area

Lockhart Ryan Memorial Park is located within the Village of New Minas. The spray park is accessible as the surface it is on is firm and level and it is made of a solid material. The spray park is accessible, but there is no defined pathway leading to it from parking. Users must cross a long grass area to get to the spray park. With the addition of a hard packed pathway, users would have reliable access to the spray park.

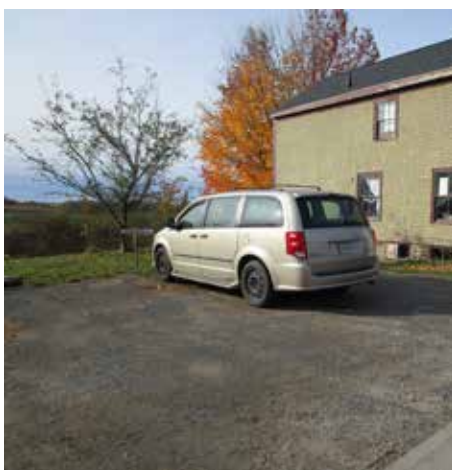
PA 3 | Parking at Canning Library

The parking at the Canning Library does not have an accessible parking stall. The reserved signage is not clear as to who the stall is reserved for. Misinterpretation can easily occur and further direction is needed. The parking lot does not contain marked parking or signage and no clear access aisle is present.

Provide accessible parking spaces for expected use adjacent to accessible building entrances. Spaces should be 2600mm wide, with a 2000mm painted access aisle. All spaces should be provided on a firm, level surface with signage painted on the pavement and displayed vertically, on a post at the head of the stall. It is also important that these stalls are not misused by those who don't require them. A permit system is recommended.

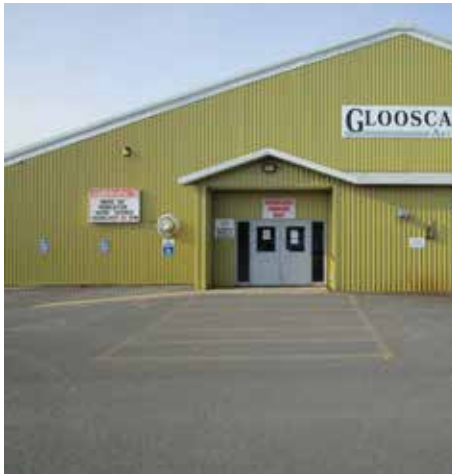
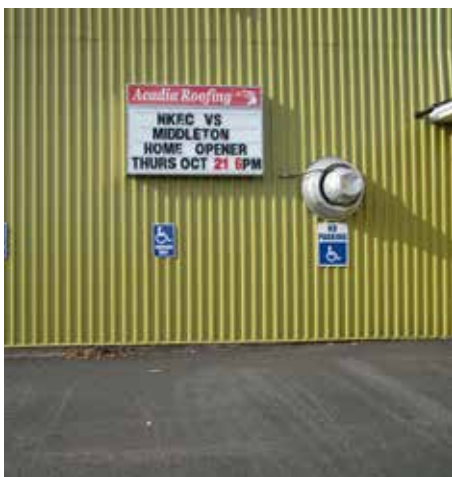
PA 4 | Accessible parking at Glooscap Arena

PA 5 | Accessible parking signage at Glooscap Arena

The accessible parking at the Glooscap Arena is present and for the most part is well designed. The issues found with the overall design include the slope of the stall itself. When an accessible parking stall is sloped it can effect whether the personal vehicle lift will operate. In addition, the signage on the wall is contradictory as it states "No parking" while also being the accessible parking stall. Finally the separated path to the entrance is elevated slightly with a lip. The original design probably did not intend on the lip being present but it is currently a tripping hazard.

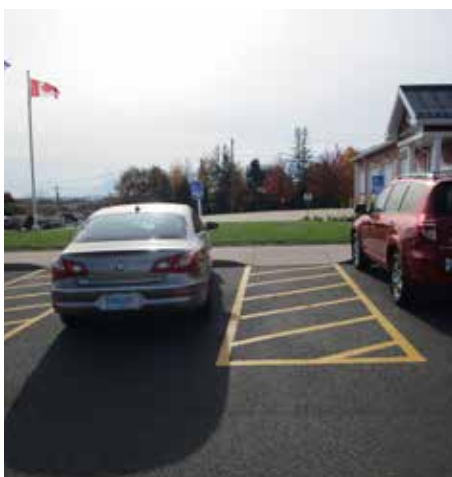
PA 6 | Parking at Canning fire hall

The parking at the Canning Fire hall is a very good example of accessible parking. Well defined accessible stalls are immediately visible and adjacent to the building entrance. All accessible stalls have a dedicated access aisle and curb cut. The pathway to the front is clear and wide enough for passing of wheeled mobility devices.

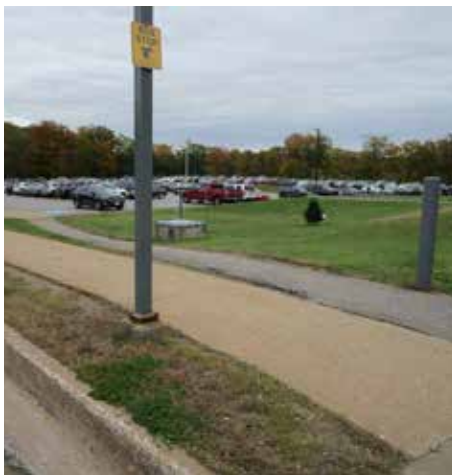
**PA 8 |** Sloped path to parking lot leading away from Hospital

Once at the top of the slope users will find that the pathway has no curb cuts. Without this, users in wheeled mobility devices would struggle to find the accessible path as there is no signage indicating a recommended direction of travel.

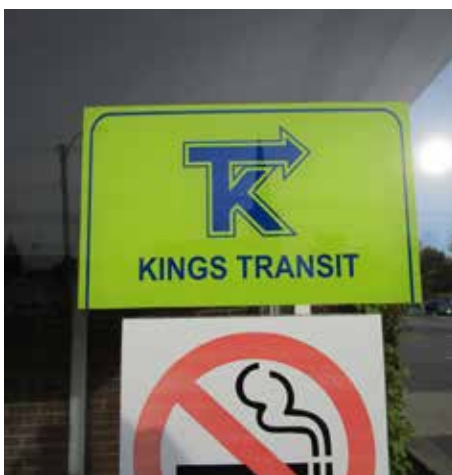
WS 6 | Bus stop signage

The sign in image WS6 was found on the interior of a bus shelter, above eye level. Visibility of the sign is sometimes difficult due to the reflection and glare coming off of the glass. The colour contrast between the font and background is good and with repositioning the sign would be more accessible. Braille should be added to the signage as well.

Signage should include specific route and contact information to check timing for the next bus arrival. It is also recommended that tactile and braille signage be provided at 1200mm height.

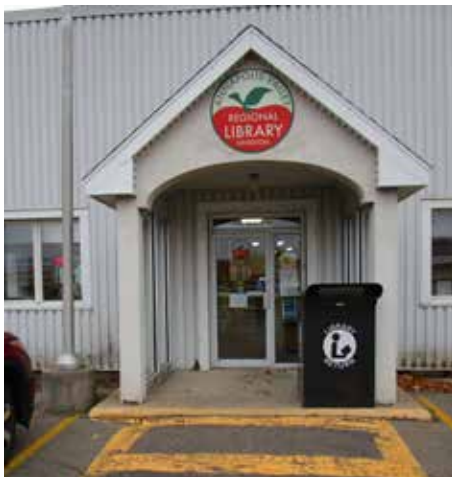
WS 8 | Kingston Library Entrance Sign

The library exterior signage is good for colour contrast but lacks in a few elements. The sign has no lighting facing it and it is hard to see at a distance and in dark conditions.
